Barak River Reconnaissance and Water Quality Screening Program, Feb. 2011

By Subijoy Dutta, P.E..¹

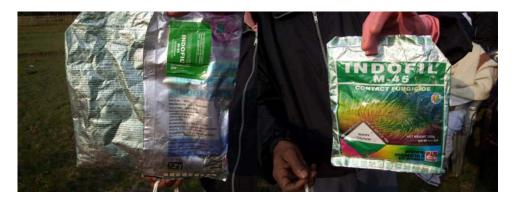
A. There were a number of farmers and a few college level students who came forward and responded that the villagers use. The pesticide they routinely use is **Indofil M-45**, a fungicide, containing Mancozeb 75% W.P. as shown below (in their original containers/bags). They apply them by mixing the powder with water

- 2. Read the pesticide Labels carefully and apply only per instruction. Do NOT use more than recommended.
- 3. DO NOT leave pesticide bags with children or ask children to apply pesticides.
- 4. Check on pesticide/chemical alternatives which would provide equally good crop protection, such as neem-leaves extract, or cayenne pepper powder

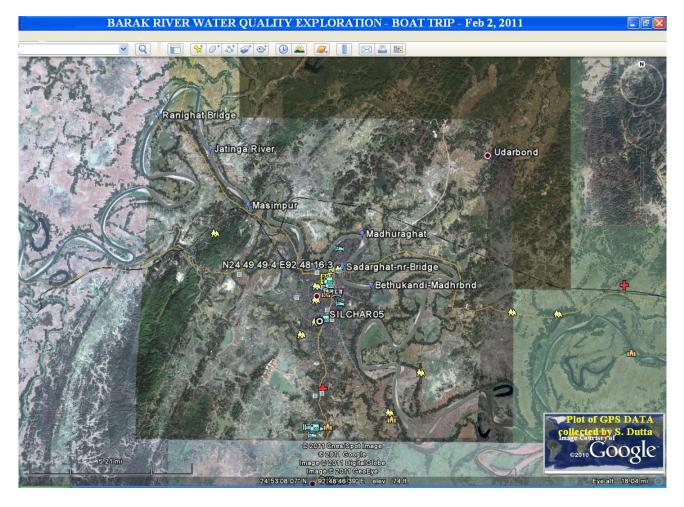
Figure 1. Barak River Boat Trip Location using Garmin GPS (image: courtesy Google)

The trip covering 40 Kms on a Row Boat, Feb 2, 2011 is shown in the Map below.

As shown on Figure 1. we collected water quality data at Bethukandi, and Madhurband Ghat, and Sadarghat before stopping at the Madhura Ghat for a short break and discussion with local people. The water quality results are Tabulated later in Table 1 and a general summary interpretation of the results are provided at the end after the tabulation of results.

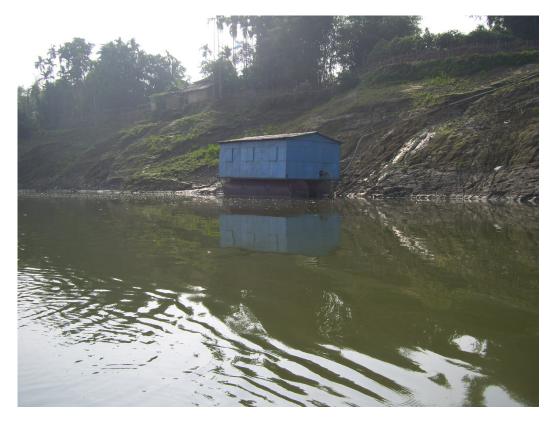
As we proceeded on our trip we came across the main water intake point for the Sllchar Township very close to the Sadarghat bridge as shown in this picture below.

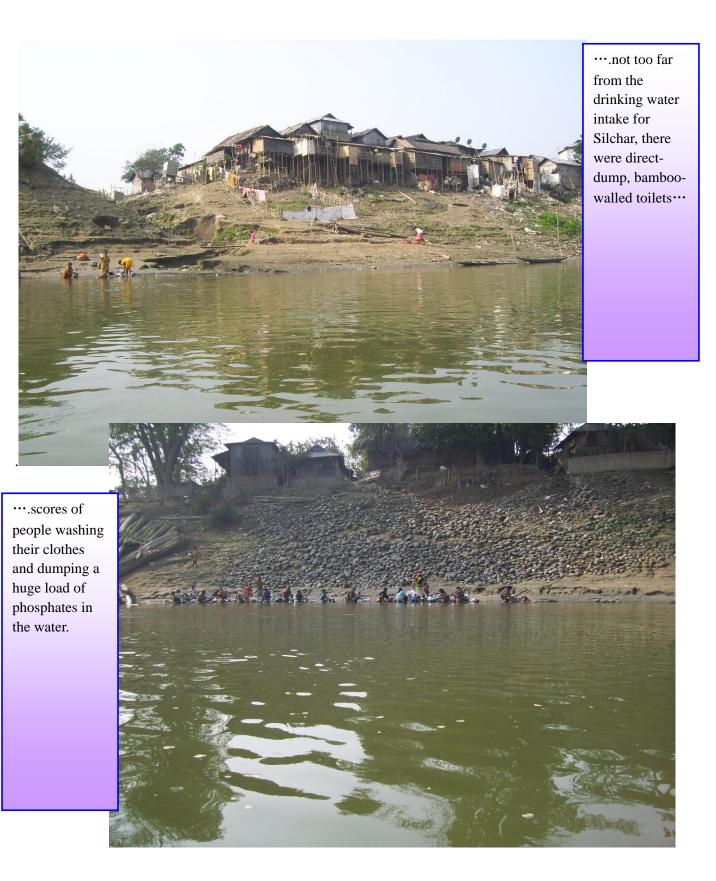
We also noted that all along the bank there were scores of people washing their clothes and dumping a huge load of phosphates in the water. I some areas, not too far from the drinking water intake for Silchar, there were direct-dump, bamboo-walled toilets sitting like a gallery on the bank of the River (see pictures below).

- 6. DO NOT dump paper, plastics, soda cans, drums or any other waste objects into the River.
- 7. Arrange to have a local trash/paper/plastic collection system, and DO NOT burn plastics, the emissions may contain Dioxins/Furans which can cause cancer or other diseases.

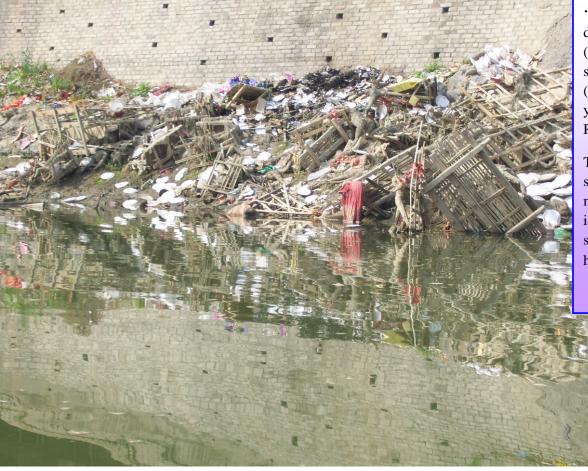
Another matter of great concern was the unwise dumping of deities (pratima) after the seasonal worships (Puja) year after year on the Barak River. This clay idols decorated and painted with various types of materials, lead paints, and other water-soluble/leachable materials which can cause serious health hazards. Generally women and children are more vulnerable to these contaminants in water.

.....unwise dumping of deities (pratima) after the seasonal worships (Puja) year after year on the Barak River..

The watersoluble/leachable materials in these idols can cause serious health hazards…

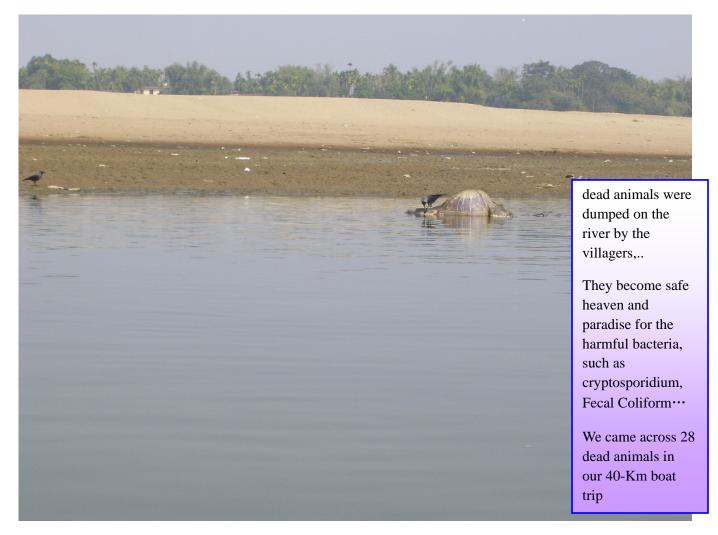
Another matter of great concern were dead cattles/animals that we observed in the river. These dead animals were dumped on the river by the villagers, who had no idea of the tremendous amount of harm/hazard that these dead-bodies could create. They become safe heaven and paradise for the harmful bacteria, such as cryptosporidium, Fecal Coliform, and others. Accidental high level exposure to these bacteria can be very serious for local people. We came across 28 dead animals in our 40-Km boat trip that day.

1. Bury dead animals/cattles in the soil or in a pit near their farm, but **DO NOT dump them in the River**

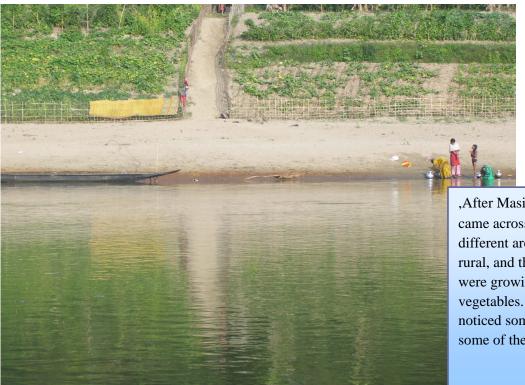
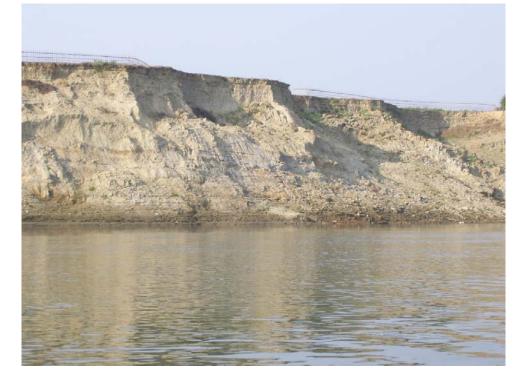
,After Masimpur....we came across a little different area, highly rural, and the farmers were growing a lot of vegetables. We also noticed some erosion in some of these areas.

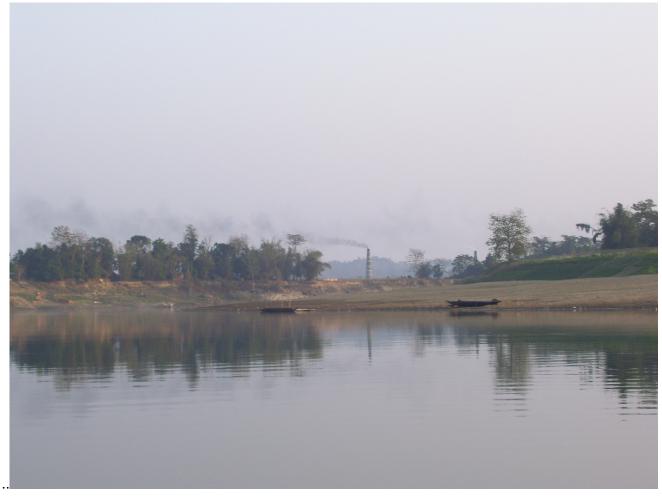
Also, noticed a few Brick factories emitting smoke

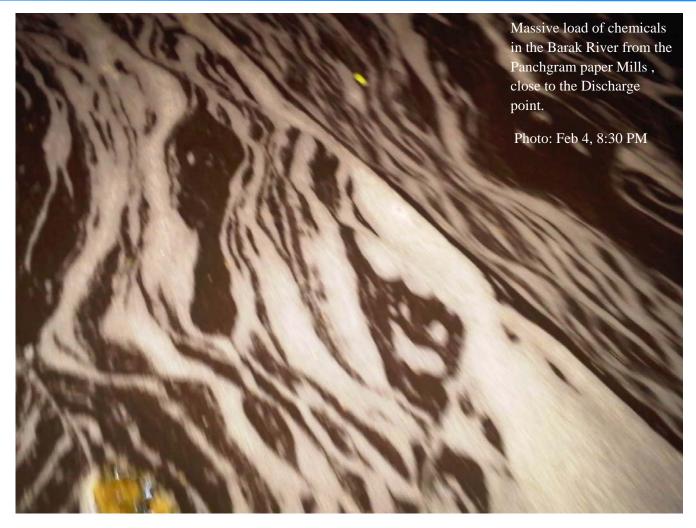
A number of people talked about their concern and asked for possible resolve and measures to protect the River. One Mr. Salim Ahmed had a very broad view and he had clearly stated the concern about steeply degrading air and water quality in the area. He referred to the air emission from the nearby Panchgram paper mill, and the massive sludge and other richly colored contaminants from the paper mill that flows directly into the River. Listening to this concern we made a special arrangement to monitor the water quality at the point where the discharge from the Panchgram paper mIII hist the Barak River. I did that two days later on Feb 4th, around 8:30 PM. The Specific conductivity and salinity of the water were recorded at three times the average value observed during the 40 Kms stretch of the River. There were floating foam and noxious odor at the site. A close shot of the flowing River with foam is shown below.

• Generally the Dissolved Oxygen content was okay in most of the areas. However, the DO was dangerously low near Panchgram paper Mills, sample #5.
